**Flood Control Project Maintenance
Levee Inspections**

Fall 2019 Levee Maintenance Deficiency Summary Report

**Flood Control Project Maintenance
Levee Inspections****LMA District Cover Sheet****Fall 2019 Levee Inspection Results****Knights Landing Ridge Drainage District**

Knights Landing Ridge Drainage District

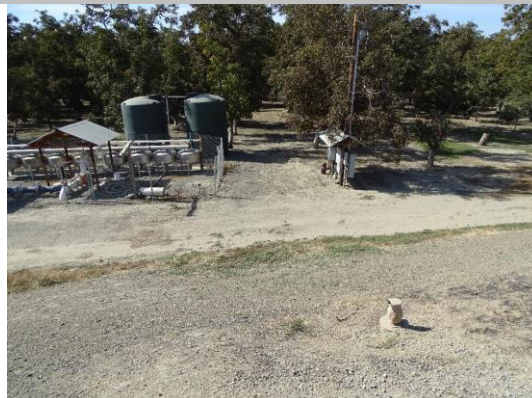
Photo 1 of 3 : UCIP_FA_2019_55685_82412.jpg

View of LS looking from levee crown

Comment Code						
Inspector Comment						
DS_ID:19361 FS_ID:55685 EP_NO: 9302 Repair Type: Urgent Crossing Status: Found UCIP Comments: 10/08/2019 Record has been updated from Non-Urgent to Urgent, excavation into WS slope and around pipe noted in USACE PI and UCIP 2013 inspection. Unable to confirm in 2019 whether excavation is still present on the WS slope due to dense vegetation on the WS. (O.Yakimov - DWR UCIP) 04/05/2013 Pipe exposed on WS slope in trench may need to be backfilled to prevent erosion under pipe. (W. Wylie - DWR UCIP) FIELD_STRUCT_DESC: 20-inch steel irrigation pipe through the levee, 8.8 feet below the crown. Pump on a steel pile structure at the waterside (WS) toe. Siphon breaker in a 12-inch steel riser on the landside (LS) slope. Possible butterfly valve at the LS toe. 36-inch pipe authorized under Automatic Board Order (ABO) issued as Permit No.9302, 1974 - Barbara Lowe Elliott). [Additional Reference(s): DWR Levee Log, 1990. USACE Sacramento O&M Manual 127, June 1953, (Station 32+94)]. FS Date: 10/8/2019

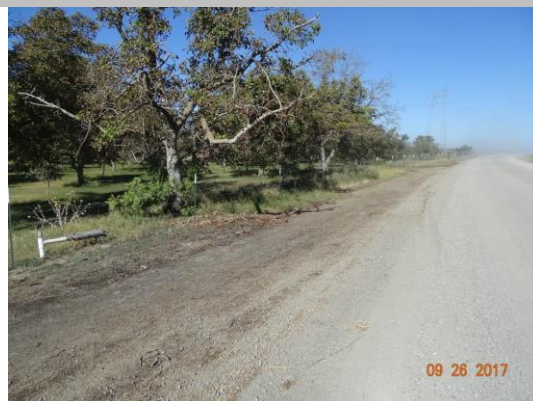
Photo 1 of 1 : FA_2019_NA0008_256_26_20190829_00008.jpg

LM Start	1.13	Rating **	M	Issue No.	26
LM End	1.29	Issue Type +	En	Location *	LS
Category	Earthen Levee			GPS Latitude/Longitude	
				Start	End
Item	Encroachments			38.730134 °	38.731873 °
				-121.678820 °	-121.680739 °
DWR ID	DWR_NA0008_01_f_2017_26				
Comment Code					
FE : Fence					
Inspector Comment					
A barbed wire fence is located on the landside slope.

View of fence on the landside slope. Fall 2017.

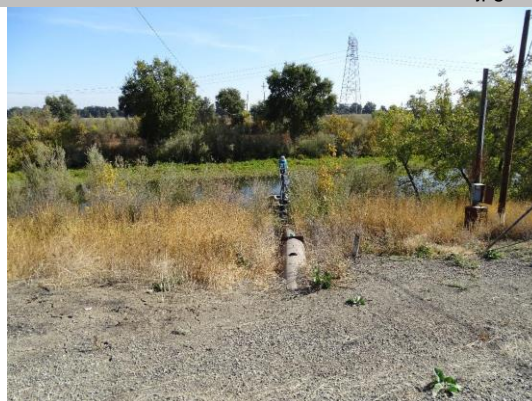
Photo 1 of 3 : UCIP_FA_2019_55692_82433.jpg

Comment Code						
Inspector Comment						
DS_ID:19363 FS_ID:55692 EP_NO: 939 Repair Type: Non-Urgent Crossing Status: Found UCIP Comments: 10/08/2019 No permit for sleeving 16-inch pipe found. Annular space between pipes not grouted. (O.Yakimov - DWR UCIP)04/05/2013 Space between 16-inch and 24-inch pipe should be grouted. There is no pump on stand at WS toe. FIELD_STRUCT_DESC: 24-inch steel irrigation pipe through the levee, 5.9 feet below the crown. 16-inch steel pipe sleeved through this pipe. No visible control valves. Pump on a pile structure in the stream. Siphon breaker on the landside (LS) slope. Pipe discharges into a concrete irrigation ditch off the LS toe. (Permit No. 939, 1943 - W. K. Lowe). [Additional Reference(s): DWR Levee Log, 1990. USACE Sacramento O&M Manual 127, June 1953, (Station 71+25)]. FS Date: 10/8/2019 8:04:40 AM

View of WS looking from levee crown

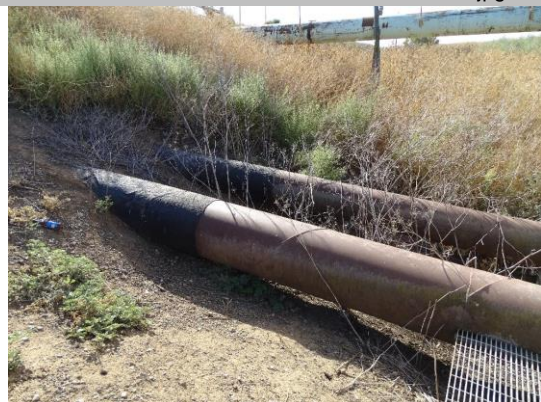
Photo 2 of 3 : UCIP_FA_2019_55711_82499.jpg

View of pipe on WS slope

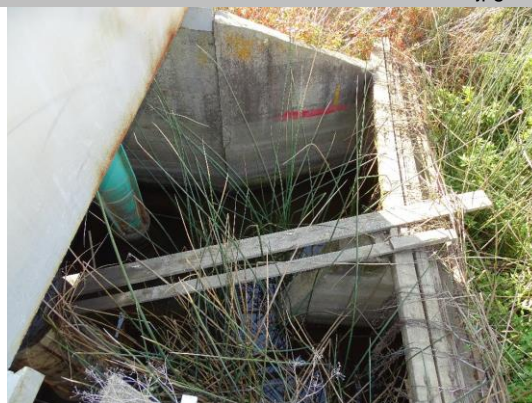
Photo 3 of 3 : UCIP_FA_2019_55711_82500.jpg

Concrete sump at pumping house

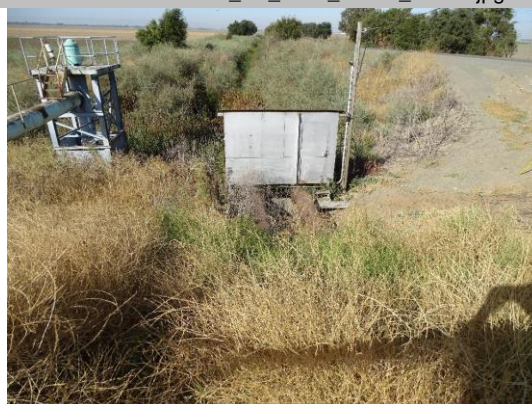
Photo 2 of 3 : UCIP_FA_2019_55712_82514.jpg

Pumphouse and pipe on LS toe

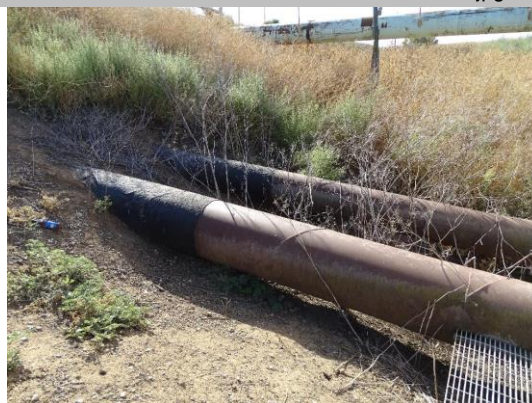
Photo 3 of 3 : UCIP_FA_2019_55712_82515.jpg

View of pipe on WS slope

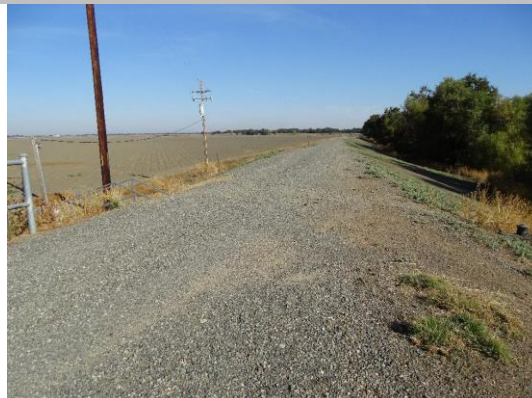
Photo 1 of 3 : UCIP_FA_2019_55721_82551.jpg

View of levee crown at the crossing

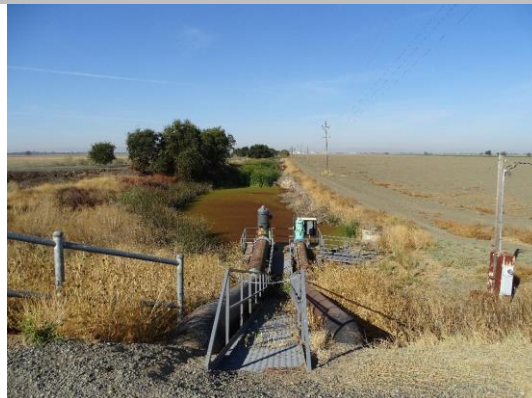
Photo 1 of 3 : UCIP_FA_2019_55722_82559.jpg

View of LS looking from levee crown

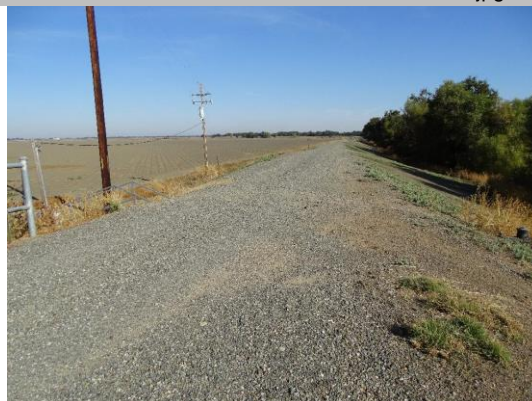
Photo 1 of 3 : UCIP_FA_2019_55724_82564.jpg

LM Start	3.31	Rating **	M	Issue No.	44
LM End	3.31	Issue Type +	En	Location *	
Category	Supplemental			GPS Latitude/Longitude	
				Start	End
Item	DRAFT DWR UCIP Field Study			38.757651 °	38.757651 °
				-121.694857 °	-121.694857 °
DWR ID	19382				
Comment Code					
Inspector Comment					
DS_ID:19382					
FS_ID:55724					
EP_NO: 5302					
Repair Type: Non-Urgent					
Crossing Status: Not Found					
UCIP Comments: 10/08/2019 Crossing not found. Candidate for electromagnetic. (O.Yakimov - DWR UCIP)					
FIELD_STRUCT_DESC: 24-inch welded steel drainage pipe through the levee, 3 feet below the crown. Pump on platform on the waterside (WS) of the levee. Siphon breaker on the WS shoulder, and flap gate on the landside (LS) outlet. (Permit No. 5302, 1966 - E. L. Wallace).					
FS Date: 10/8/2019 2:48:13 PM

View of levee crown at the crossing

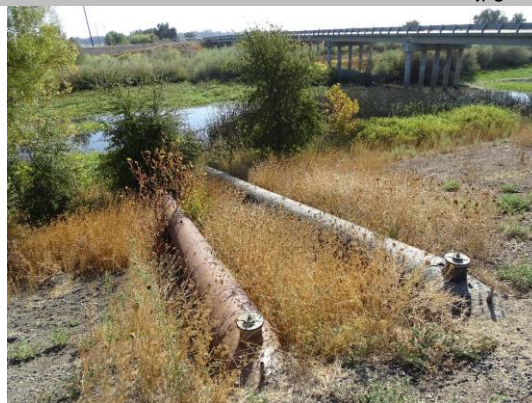
Photo 3 of 3 : UCIP_FA_2019_55724_82566.jpg

View of WS looking from levee crown

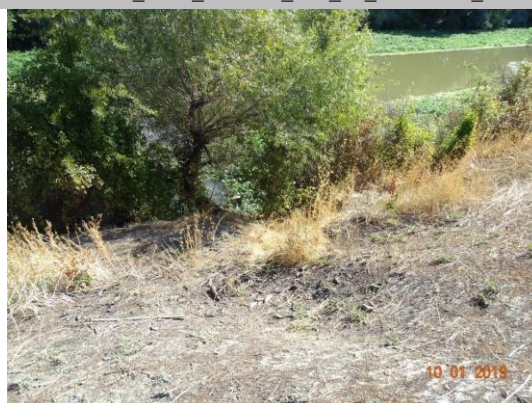
Photo 1 of 2 : FA_2019_NA0008_256_31_20191001_00039.jpg

LM Start	3.86	Rating **	M	Issue No.	31
LM End	3.86	Issue Type +	Ma	Location *	WS
Category	Earthen Levee			GPS Latitude/Longitude	
				Start	End
Item	Erosion / Bank Caving			38.763751 °	38.763751 °
				-121.701398 °	-121.701398 °
DWR ID	DWR_NA0008_01_s_2018_31				
Comment Code					
E1 : Note and monitor erosion site.					
Inspector Comment					
The erosion appears to be stable. LMA continues to monitor.

View of the erosion at the waterside toe. Fall 2019.

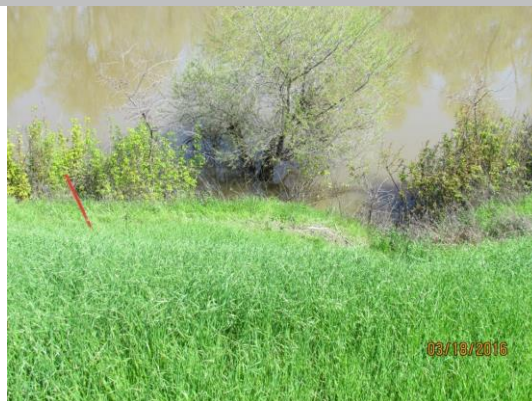
Photo 2 of 2 : FA_2019_NA0008_256_31_20190829_00010.jpg

View of the erosion at the toe of the levee on the waterward side. Spring 2016.

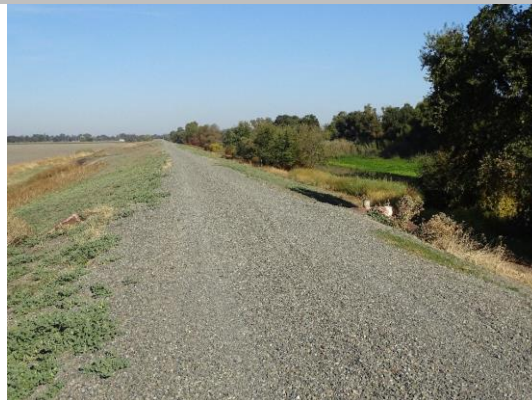
Photo 1 of 3 : UCIP_FA_2019_55725_82571.jpg

View of levee crown at the crossing

Comment Code						
Inspector Comment						
DS_ID:19367 FS_ID:55725 EP_NO: 4443 Repair Type: Non-Urgent Crossing Status: Found UCIP Comments: 10/08/2019 Pipe not covered on levee slopes and doesn't have an adequate cover at crown. (O.Yakimov - DWR UCIP)04/05/2013 Pipe does not have adequate cover at crown. FIELD_STRUCT_DESC: 16-inch steel drainage pipe through the levee, 0.5 feet below the crown. Pad constructed over pipe for vehicular crossing. Pump on metal structure on the landside (LS). Flap gate on the waterside (WS) end. Siphon breaker on the pipe on the WS. Slide gate on the LS toe. (Permit No. 4443, 1963 - Reclamation District No. 730). Design drawings available in permit. [Additional Reference(s): DWR Levee Log, 1990]. FS Date: 10/8/2019 2:52:37 PM

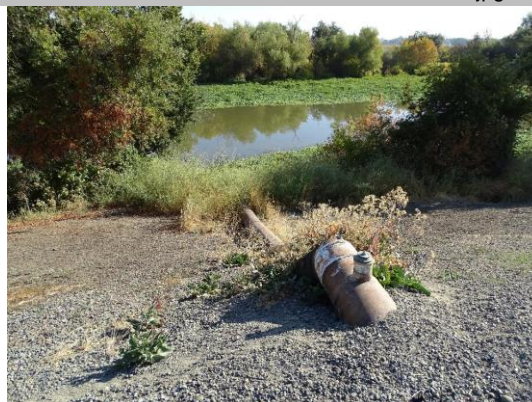
Photo 2 of 3 : UCIP_FA_2019_55725_82572.jpg

View of WS looking from levee crown

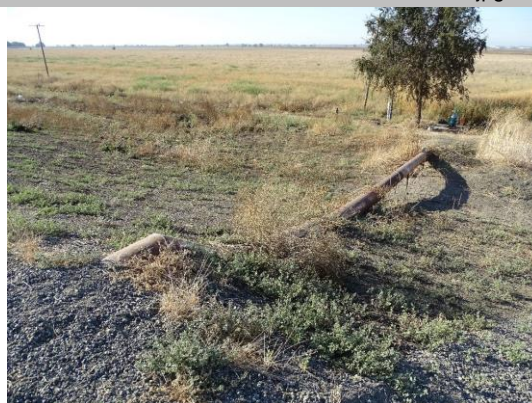
Photo 3 of 3 : UCIP_FA_2019_55725_82573.jpg

View of LS looking from levee crown

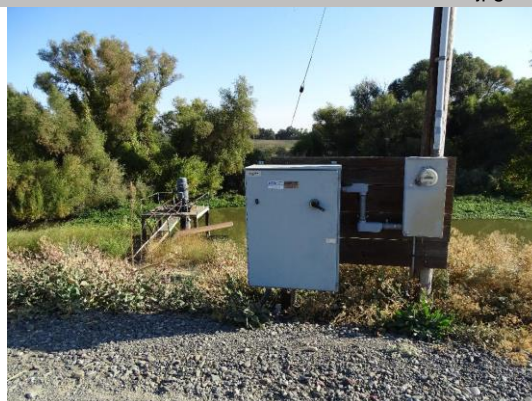
Photo 1 of 3 : UCIP_FA_2019_55745_82656.jpg

Comment Code						
Inspector Comment						
DS_ID:19397						
FS_ID:55745						
EP_NO: 5276						
Repair Type: Non-Urgent						
Crossing Status: Found						
UCIP Comments: 10/08/2019 Pipe is capped under pumping platform.						
(O.Yakimov - DWR UCIP)04/05/2013 Pipe appears abandoned at this time.						
FIELD_STRUCT_DESC: 2 of 2: 20-inch steel irrigation pipe through the levee, 4.9 feet below the crown. Vertical pump unit on pile structure in stream. Siphon breaker on the landside (LS) shoulder in a 16-inch steel riser. Flap gate on the LS end. Pipe discharges into an irrigation ditch on the LS. Steel plate welded over end of pipe at pump structure.						
(Replaced an existing 18-inch pipe at this location under Permit No. 5276, 1966 - Reclamation District No. 730). [Additional Reference(s): DWR Levee Log, 1990].						
FS Date: 10/8/2019 9:26:13 AM

View of WS looking from levee crown

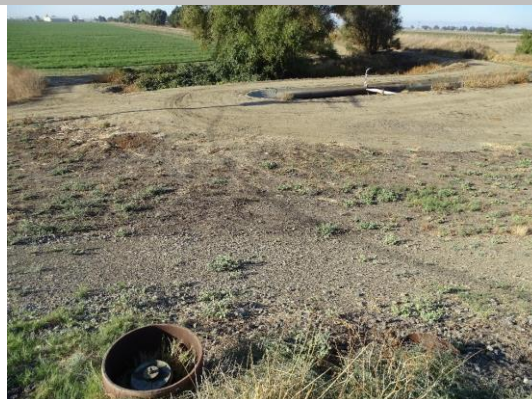
Photo 2 of 3 : UCIP_FA_2019_55745_82659.jpg

View of LS looking from levee crown

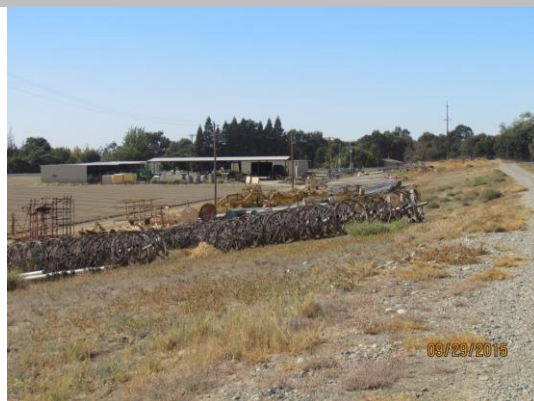
Photo 1 of 2 : FA_2019_NA0008_256_7_20190829_00001.jpg

LM Start	6.06	Rating **	M	Issue No.	7
LM End	6.34	Issue Type +	En	Location *	LS
Category	Earthen Levee			GPS Latitude/Longitude	
				Start	End
Item	Encroachments			38.789529 °	38.792433 °
				-121.722814 °	-121.726463 °
DWR ID	DWR_NA0008_01_f_2018_7				
Comment Code					
EQ : Equipment					
Inspector Comment					
Equipment and fence are on the landside slope of the levee.

View of the equipment on the landward side of the levee looking upstream. Fall 2015.

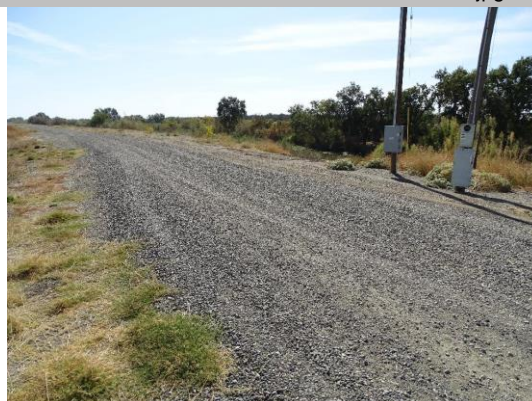
Photo 1 of 3 : UCIP_FA_2019_55754_82699.jpg

View of levee crown at the crossing

Comment Code						
Inspector Comment						
DS_ID:19369 FS_ID:55754 EP_NO: 9322 Repair Type: Urgent Crossing Status: Found UCIP Comments: 10/08/2019 Record updated from No Action Needed to Urgent due to issues with levee. Waterward slope of levee berm has been disturbed and not compacted properly. Multiple sinkholes from 1 to 2 feet in diameter found around pumping platform on WS. Signs of runoff observed from the slope of WS berm towards the riverbank. (O.Yakimov - DWR UCIP) FIELD_STRUCT_DESC: 24-inch steel irrigation pipe through the levee, 4.7 feet below the crown. Pump on pile structure in stream. Air vent on the landside (LS) shoulder. Sand media filters connected to LS end of crossing. Service pole on the waterside (WS) berm. Wide levee section. (24-inch pipe authorized under Automatic Board Order (ABO) as permit No. 9322, 1974 - Davidella H. Hershey Estates). [Additional Reference(s): DWR Levee Log, 1990. USACE Sacramento O&M Manual 127, June 1953, (Station 44+35)]. FS Date: 10/8/2019 12:41:23 PM

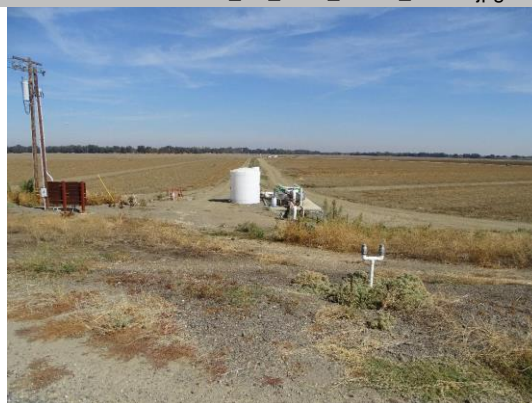
Photo 2 of 3 : UCIP_FA_2019_55754_82704.jpg

View of LS looking from levee crown

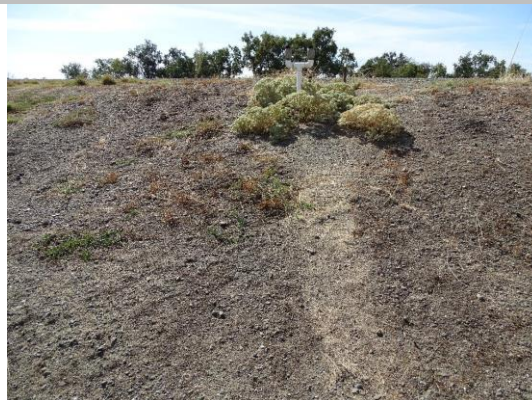
Photo 3 of 3 : UCIP_FA_2019_55754_82700.jpg

View of LS slope at crossing

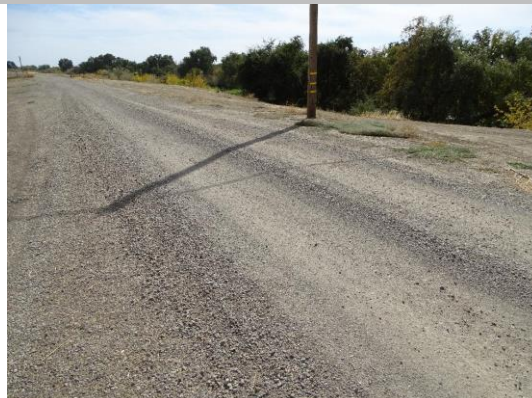
Photo 1 of 3 : UCIP_FA_2019_55757_82719.jpg

Comment Code					
Inspector Comment					
DS_ID:19370 FS_ID:55757 EP_NO: 9320 Repair Type: Non-Urgent Crossing Status: Found UCIP Comments: 10/08/2019 Crossing looks abandoned (O.Yakimov - DWR UCIP)09/27/2017 Received updated information from DWR levee inspector, Zachary Jojola, confirming that this crossing is still abandoned. Recommend pipe be abandoned properly according to Title 23 requirements. Updated photos have been added to this report. (DWR UCIP - O. Magana)04/09/2013 Appears abandoned as pump is missing from platform. (DWR UCIP - W. Wylie) FIELD_STRUCT_DESC: 16-inch steel irrigation pipe through the levee, 2.8 feet below the crown. Pipe discharges into a 36-inch concrete standpipe at the levee toe. Pump on steel pile structure in stream with metal walkway. Two service poles on the waterside (WS) slope. (Automatic Board Order (ABO) issued as Permit No. 9320, 1974 - Ralph W. Pollock). [Additional Reference(s): DWR Levee Log, 1990. USACE Sacramento O&M Manual 127, June 1953, (Station 52+00) (15-inch pipe listed)]. FS Date: 10/8/2019 1:23:54 PM

View of levee crown at the crossing

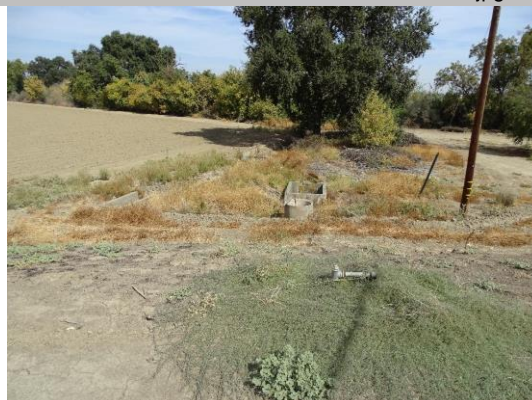
Photo 2 of 3 : UCIP_FA_2019_55757_82720.jpg

View of LS looking from levee crown

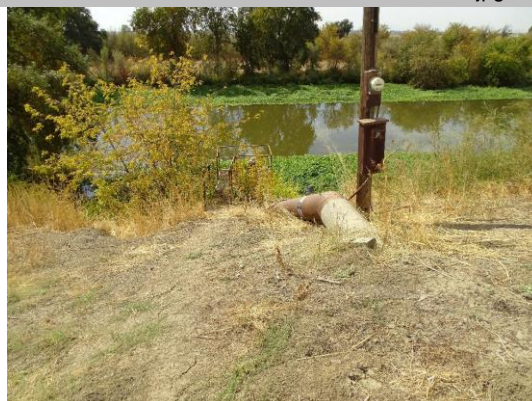
Photo 3 of 3 : UCIP_FA_2019_55757_82723.jpg

View of WS looking from levee crown

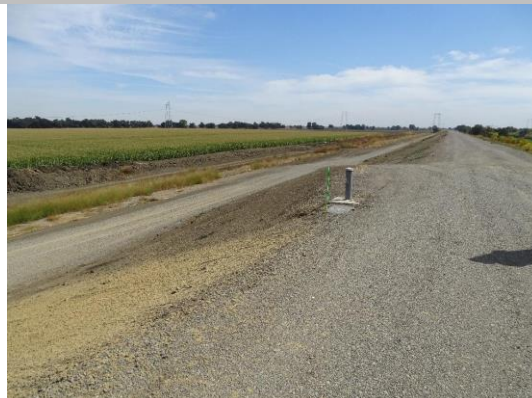
Photo 1 of 3 : UCIP_FA_2019_55758_82732.jpg

Air vent on LS shoulder

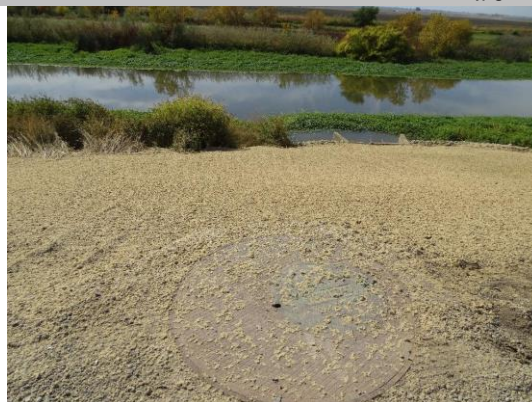
Photo 2 of 3 : UCIP_FA_2019_55758_82731.jpg

Closure device in manhole at WS soulder

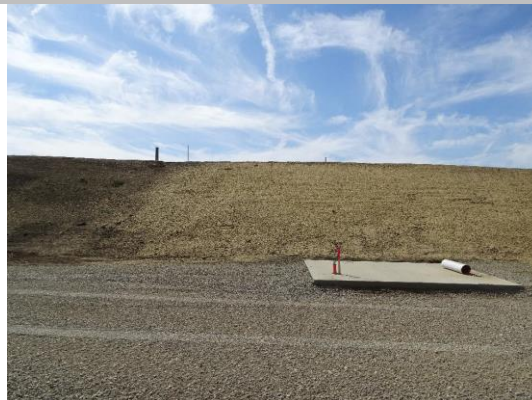
Photo 3 of 3 : UCIP_FA_2019_55758_82730.jpg

Comment Code						
Inspector Comment						
DS_ID:25471 FS_ID:55758 EP_NO: N/A Repair Type: Non-Urgent Crossing Status: Found UCIP Comments: 10/08/2019 Missing permit number for this crossing. (O.Yakimov - DWR UCIP) 09/27/2017 Previous 12-inch pipe (see DSID 19371) was replaced with new 18-inch steel pipe as part of the Knights Landing 2015 Levee Repair Project. No integrity issues were recorded by DWR levee inspector Zachary Jojola. Inspector located the concrete headwall, flap gate, and manual operator for the 12-inch pipe. No as-builts have been received to confirm the details of the new pipe or the abandoned structures allowed to remain from the previous structure. UCIP staff will need to follow-up with LMA to obtain as-built records and authorizing permit. (DWR UCIP - O. Magana)09/01/2016 - pipe was replaced as part of the knights landing 2015 levee repair project. UCIP has requested the As-builts from the LMA and will update the record when those are received. (T. Hatch/UCIP) FIELD_STRUCT_DESC: 18-inch steel drainage pipe through the levee, at an unknown depth. Pump in a metal pump house on the landside (LS) toe in a drainage canal. Concrete headwall on the waterside (WS) toe. Flap gate on the WS at the headwall. Manhole labeled storm drain at the WS shoulder, ait vent on LS shoulder. [Additional Reference(s): DWR Levee Log, 1990. USACE Sacramento O&M Manual 127, June 1953, (Station 103+21.8), listed as a 24-inch pipe and a 12-inch pipe]. FS Date: 10/8/2019 1:36:03 PM

LS levee slope looking towards levee

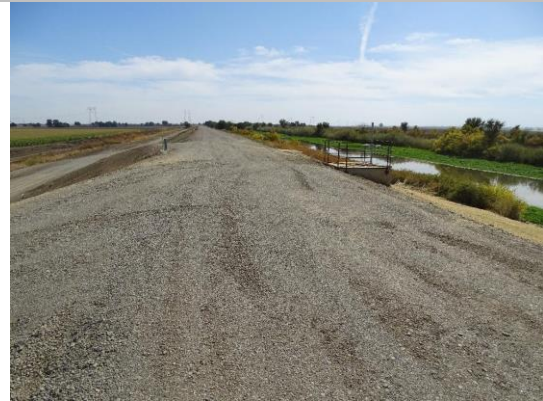
Photo 1 of 3 : UCIP_FA_2019_55761_82744.jpg

Comment Code						
Inspector Comment						
DS_ID:19399 FS_ID:55761 EP_NO: 9320 Repair Type: Non-Urgent Crossing Status: Found UCIP Comments: 10/08/2019 Crossing has been modified as part of the Knights Landing 2015 Levee Repair Project. A concrete box with slide gate was constructed on WS shoulder, a concrete pad with electrical wiring installed at LS toe, pipe inlet on LS is modified and revetted. New flap gate at WS end. Need to request as-built drawings. Missing permit for these modifications. (O.Yakimov - DWR UCIP) FIELD_STRUCT_DESC: 2 of 2: 24-inch steel drainage pipe through the levee, 21 feet below the crown. Slide gate on the waterside (WS) end. Open on the landside (LS) end. LS toe cobble revetted. Service pole on the LS slope. (24-inch pipe [HLM 1.9] authorized under Automatic Board Order (ABO) issued as Permit No. 9320, 1974 - Ralph W. Pollock). [Additional Reference(s): DWR Levee Log, 1990. USACE Sacramento O&M Manual 127, June 1953, (Station 103+21.8)]. FS Date: 10/8/2019 2:13:30 PM

View of levee crown at the crossing

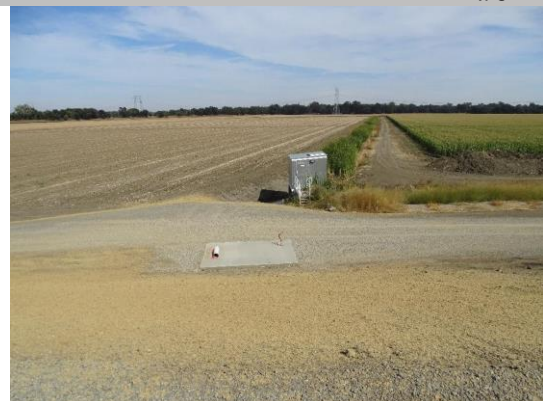
Photo 2 of 3 : UCIP_FA_2019_55761_82749.jpg

View of LS looking from levee crown

Comment Code						
Inspector Comment						
DS_ID:19399 FS_ID:55761 EP_NO: 9320 Repair Type: Non-Urgent Crossing Status: Found UCIP Comments: 10/08/2019 Crossing has been modified as part of the Knights Landing 2015 Levee Repair Project. A concrete box with slide gate was constructed on WS shoulder, a concrete pad with electrical wiring installed at LS toe, pipe inlet on LS is modified and revetted. New flap gate at WS end. Need to request as-built drawings. Missing permit for these modifications. (O.Yakimov - DWR UCIP) FIELD_STRUCT_DESC: 2 of 2: 24-inch steel drainage pipe through the levee, 21 feet below the crown. Slide gate on the waterside (WS) end. Open on the landside (LS) end. LS toe cobble revetted. Service pole on the LS slope. (24-inch pipe [HLM 1.9] authorized under Automatic Board Order (ABO) issued as Permit No. 9320, 1974 - Ralph W. Pollock). [Additional Reference(s): DWR Levee Log, 1990. USACE Sacramento O&M Manual 127, June 1953, (Station 103+21.8)]. FS Date: 10/8/2019 2:13:30 PM

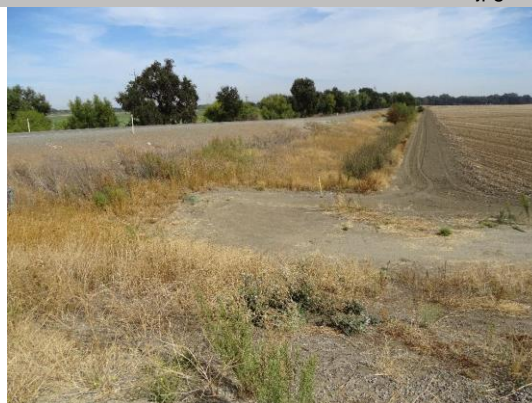
Photo 1 of 2 : UCIP_FA_2019_55763_82751.jpg

LM Start	2.26	Rating **	M	Issue No.	27
LM End	2.26	Issue Type +	En	Location *	
Category	Supplemental			GPS Latitude/Longitude	
				Start	End
Item	DRAFT DWR UCIP Field Study			38.748282 °	38.748282 °
				-121.692652 °	-121.692652 °
DWR ID	19388				
Comment Code					
Inspector Comment					
DS_ID:19388 FS_ID:55763 EP_NO: 15517 Repair Type: Non-Urgent Crossing Status: Indicator Found UCIP Comments: 10/08/2019 Marker visible only on LS. (O.Yakimov - DWR UCIP)04/09/2013 Pipe alignment should be marked at levee crossing. FIELD_STRUCT_DESC: 8-inch steel natural gas pipeline through the levee, 50 feet below the crown. (Permit No. 15517, 1991 - Chevron U.S.A., Inc.). Design drawings available in permit. FS Date: 10/8/2019 2:33:02 PM

View of gas line marker on LS

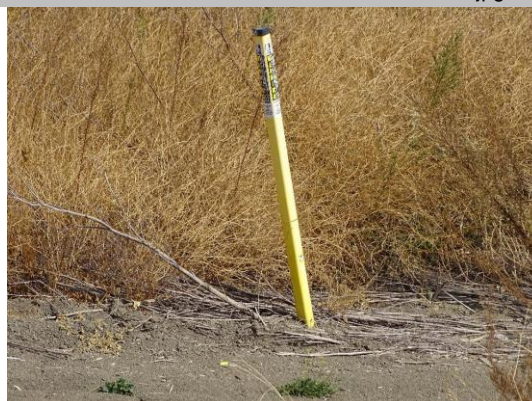
Photo 2 of 2 : UCIP_FA_2019_55763_82752.jpg

LM Start	2.26	Rating **	M	Issue No.	27 (cont)	
LM End	2.26	Issue Type +	En	Location *		
Category	Supplemental			GPS Latitude/Longitude		
				Start	End	
Item	DRAFT DWR UCIP Field Study			38.748282 °	38.748282 °	
				-121.692652 °	-121.692652 °	
DWR ID	19388					
Comment Code						
Inspector Comment						
DS_ID:19388 FS_ID:55763 EP_NO: 15517 Repair Type: Non-Urgent Crossing Status: Indicator Found UCIP Comments: 10/08/2019 Marker visible only on LS. (O.Yakimov - DWR UCIP)04/09/2013 Pipe alignment should be marked at levee crossing. FIELD_STRUCT_DESC: 8-inch steel natural gas pipeline through the levee, 50 feet below the crown. (Permit No. 15517, 1991 - Chevron U.S.A., Inc.). Design drawings available in permit. FS Date: 10/8/2019 2:33:02 PM

Gas line marker

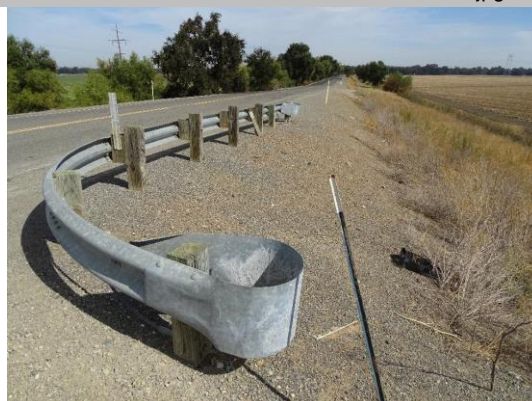
Photo 1 of 2 : UCIP_FA_2019_55764_82753.jpg

DS_ID:19386
FS_ID:55764
EP_NO: 13164
Repair Type: Non-Urgent
Crossing Status: Indicator Found
UCIP Comments: 10/08/2019 Crossing marker on levee Unit 02 is missing. Having a marker on County Road 16 shoulder is not enough to find exact crossing location on levee. Crossing has been downgraded to "Non-Urgent" due to reclassification of gas lines. (O.Yakimov - DWR UCIP)09/01/2016 - Markers present on the edges of Road 16. Alignment indicated by markers shows parallel alignment to the levee. Permit indicates pipe crosses levee and therefore should have markers indicating where it crosses the levee. (T. Hatch/UCIP)04/08/2013 - Need to have pipe located and marked properly if still in use. (W. Wylie/UCIP)
FIELD_STRUCT_DESC: 4-inch steel natural gas collection pipe through the levee, 3.2 feet below the crown. Permit indicates that the pipe was installed on the northern shoulder of Road 16 and crosses the Knights Landing Ridge Cut on the northern side of the Road 16 bridge. (Permit No. 13164, 1981 - Shell Oil Company).

South shoulder of Co Rd 16 with gas line marker installed

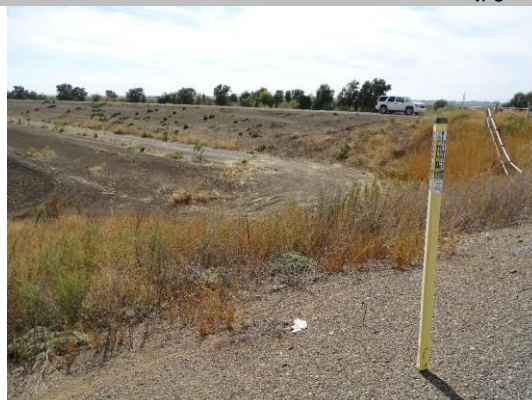
Photo 2 of 2 : UCIP_FA_2019_55764_82754.jpg

Gas line marker

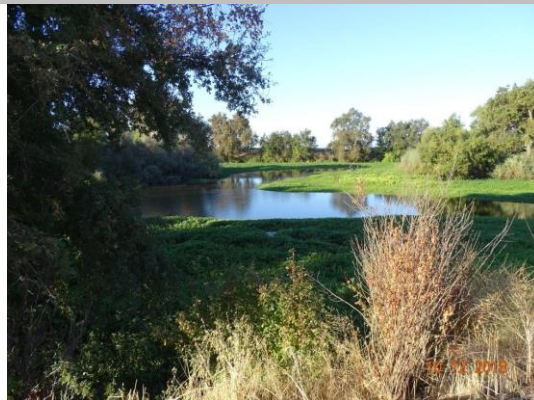
Photo 2 of 2 : FA_2019_NA0008_257_9_20190829_00004.jpg

LM Start	2.98	Rating **	M	Issue No.	9 (cont)	
LM End	3.11	Issue Type +	Ma	Location *	WS	
Category	Supplemental			GPS Latitude/Longitude		
				Start		End
Item	2017 USACE Erosion Survey			38.758587 °		38.760053 °
				-121.693359 °		-121.694686 °
DWR ID	DWR_NA0008_02_f_2018_9					
Comment Code						
Inspector Comment						
2017 Site ID: KLR 3.1 L						
Status: Eroding						
2017 Field Notes: Access Issues - Could not observe						
Site History: 2006 - The whole levee toe area is slowly slumping into the channel (creep) due to dewatering and poor slope soils. Occasional piping in the levee slope evident as well. Pistol-butted trees at the levee toe indicate slow retreat. 2011 - Slumping of the levee toe.

View of the opening within the center channel. Fall 2018.

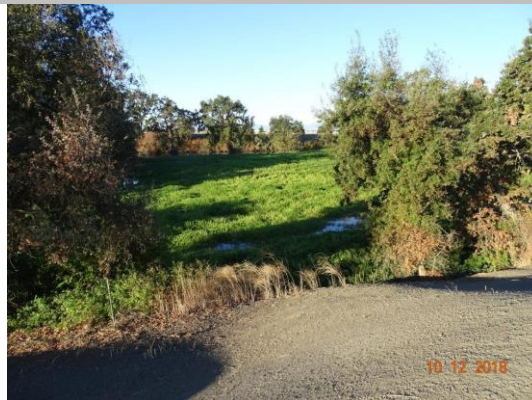
Photo 2 of 2 : FA_2019_NA0008_257_14_20190829_00006.jpg

LM Start	3.31	Rating **	A/W	Issue No.	14 (cont)
LM End	3.31	Issue Type +	Ma	Location *	WS
Category	Earthen Levee			GPS Latitude/Longitude	
				Start	End
Item	Erosion / Bank Caving			38.762301 °	38.762301 °
				-121.697190 °	-121.697190 °
DWR ID	DWR_NA0008_02_f_2018_14				
Comment Code					
E1 : Note and monitor erosion site.					
Inspector Comment					
The primary channel changes course throughout the water year and erodes the slope through an opening in the center barrier. The slope appears to be stable and erosion is not within the prism. The levee is further reinforced by the newly constructed berm on the land side. Recommend monitoring.

View of the opening within the main channel, facing upstream. Fall 2018.

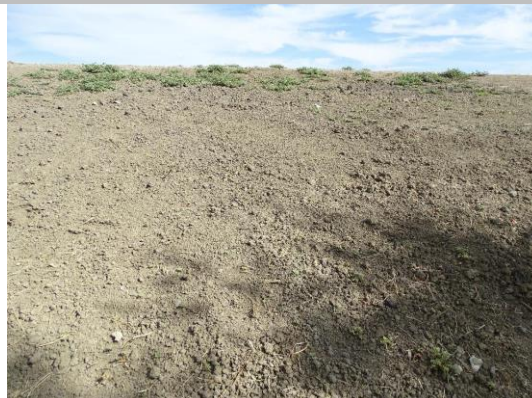
Photo 1 of 3 : UCIP_FA_2019_55774_82795.jpg

LM Start	3.68	Rating **	M	Issue No.	29
LM End	3.68	Issue Type +	En	Location *	
Category	Supplemental			GPS Latitude/Longitude	
				Start	End
Item	DRAFT DWR UCIP Field Study			38.766573 °	38.766573 °
				-121.700885 °	-121.700885 °
DWR ID	19373				
Comment Code					
Inspector Comment					
DS_ID:19373 FS_ID:55774 EP_NO: N/A Repair Type: Non-Urgent Crossing Status: Not Found UCIP Comments: 10/08/2019 Not found concrete distribution box on WS slope. Unable to locate permit for pipe abandonment. (O.Yakimov - DWR UCIP)04/09/2013 14-inch pipe debris on the WS slope. FIELD_STRUCT_DESC: *ABANDONED* 18-inch reinforced concrete drainage pipe through the levee, 6.5 feet below the crown. No gates or valves. 5-foot by 5-foot concrete distribution box on the waterside (WS) slope (Russell). [Additional Reference(s): DWR Levee Log, 1966]. FS Date: 10/8/2019 3:37:43 PM

Signs of soil disturbed on WS levee slope

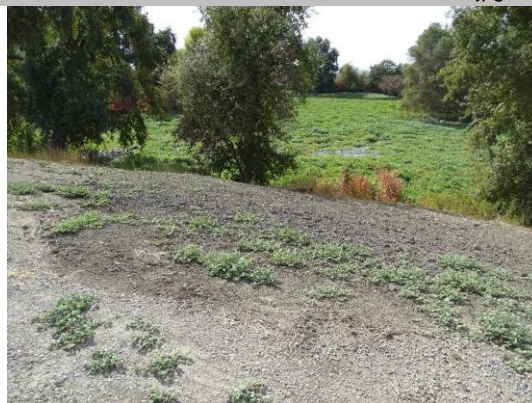
Photo 2 of 3 : UCIP_FA_2019_55774_82796.jpg

View of WS looking from levee crown

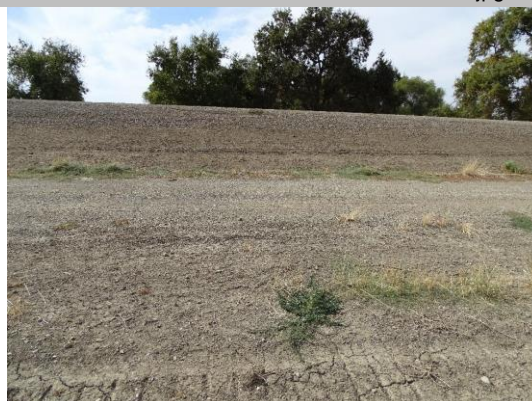
Photo 3 of 3 : UCIP_FA_2019_55774_82797.jpg

LM Start	3.68	Rating **	M	Issue No.	29 (cont)	
LM End	3.68	Issue Type +	En	Location *		
Category	Supplemental			GPS Latitude/Longitude		
				Start	End	
Item	DRAFT DWR UCIP Field Study			38.766573 °	38.766573 °	
				-121.700885 °	-121.700885 °	
DWR ID	19373					
Comment Code						
Inspector Comment						
DS_ID:19373 FS_ID:55774 EP_NO: N/A Repair Type: Non-Urgent Crossing Status: Not Found UCIP Comments: 10/08/2019 Not found concrete distribution box on WS slope. Unable to locate permit for pipe abandonment. (O.Yakimov - DWR UCIP)04/09/2013 14-inch pipe debris on the WS slope. FIELD_STRUCT_DESC: *ABANDONED* 18-inch reinforced concrete drainage pipe through the levee, 6.5 feet below the crown. No gates or valves. 5-foot by 5-foot concrete distribution box on the waterside (WS) slope (Russell). [Additional Reference(s): DWR Levee Log, 1966]. FS Date: 10/8/2019 3:37:43 PM

View of LS slope looking towards levee

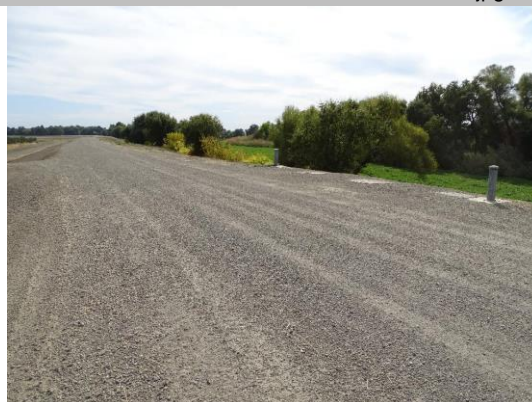
Photo 1 of 3 : UCIP_FA_2019_55749_82670.jpg

Comment Code					
Inspector Comment					
DS_ID:25571					
FS_ID:55749					
EP_NO: N/A					
Repair Type: No Action Needed					
Crossing Status: Found					
UCIP Comments: 10/08/2019 No issues recorded during inspection (O.Yakimov - DWR UCIP)					
FIELD_STRUCT_DESC: 16-inch steel discharge pipe through the levee, 3-feet below the crown. Pump house on pile structure in drainage ditch on the landward side. Siphon breaker and positive closure device butterfly valve with handwheel operator on the pipe on the waterward side. Pipe replaces a section of pipe through the levee butt welded to the original pipe approximately 35-feet from levee centerline on both levee slopes. Service pole on pump house (Permit No. 9317-1, applicant - RD730, issued 07/10/2014)					
FS Date: 10/8/2019 12:32:09 PM

View of levee crown at the crossing

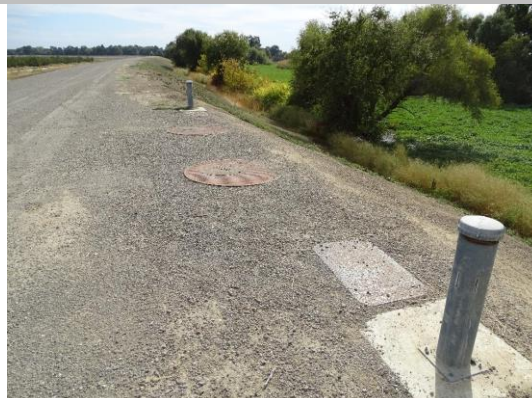
Photo 2 of 3 : UCIP_FA_2019_55749_82671.jpg

Siphon breaker and positive closure device on WS shoulder

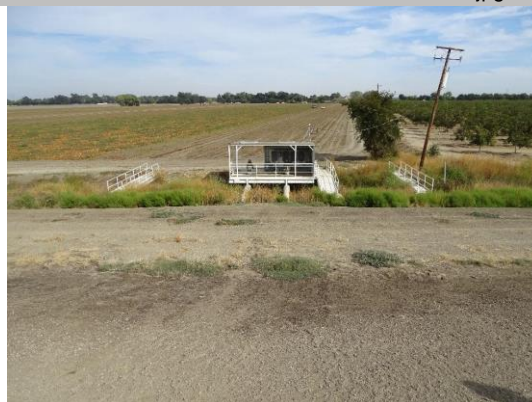
Photo 3 of 3 : UCIP_FA_2019_55749_82672.jpg

View of LS looking from levee crown

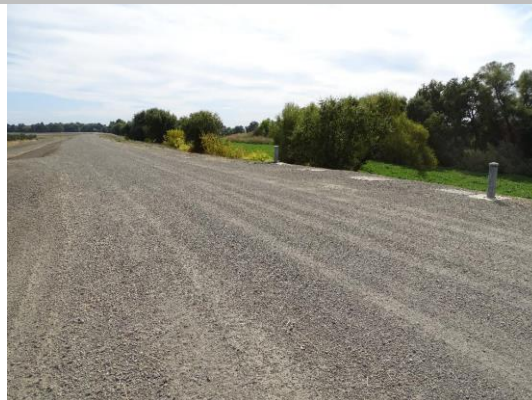
Photo 1 of 3 : UCIP_FA_2019_54351_82677.jpg

DS_ID:25572
FS_ID:54351
EP_NO: N/A
Repair Type: No Action Needed
Crossing Status: Found
UCIP Comments: 10/08/2019 No issues recorded during inspection (O.Yakimov - DWR UCIP)
FIELD_STRUCT_DESC: 24-inch steel discharge pipe through the levee, 6.5-feet below the crown. Pump house on pile structure in drainage ditch on the landward side. Siphon breaker and positive closure device butterfly valve with handwheel operator on the pipe on the waterward side. Pipe replaces a section of pipe through the levee butt welded to the original pipe approximately 37-feet from levee centerline on both levee slopes. Service pole on pump house. (Permit No. 9317-1, applicant - RD730, issued 07/10/2014 gives authorization of emergency removal and replacement of the pipe in September 2012.)
FS Date: 10/8/2019

View of levee crown at the crossing

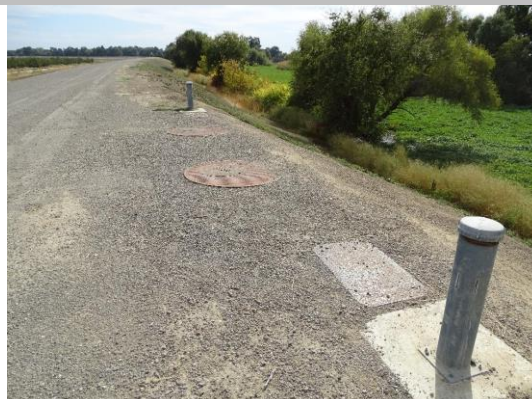
Photo 2 of 3 : UCIP_FA_2019_54351_82678.jpg

Siphon breaker and positive closure device on WS shoulder

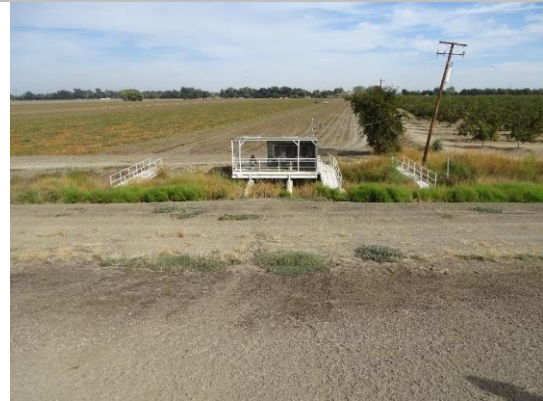
Photo 3 of 3 : UCIP_FA_2019_54351_82679.jpg

Comment Code						
Inspector Comment						
DS_ID:25572 FS_ID:54351 EP_NO: N/A Repair Type: No Action Needed Crossing Status: Found UCIP Comments: 10/08/2019 No issues recorded during inspection (O.Yakimov - DWR UCIP) FIELD_STRUCT_DESC: 24-inch steel discharge pipe through the levee, 6.5-feet below the crown. Pump house on pile structure in drainage ditch on the landward side. Siphon breaker and positive closure device butterfly valve with handwheel operator on the pipe on the waterward side. Pipe replaces a section of pipe through the levee butt welded to the original pipe approximately 37-feet from levee centerline on both levee slopes. Service pole on pump house. (Permit No. 9317-1, applicant - RD730, issued 07/10/2014 gives authorization of emergency removal and replacement of the pipe in September 2012.) FS Date: 10/8/2019

View of LS looking from levee crown

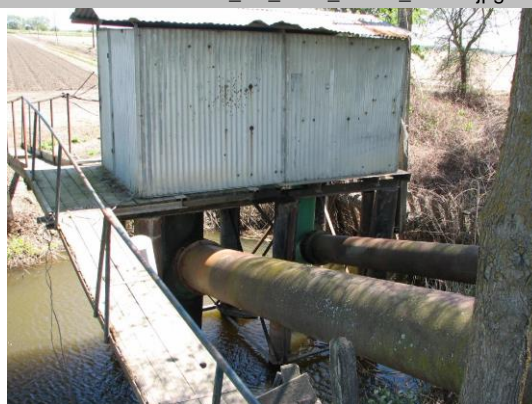
Photo 2 of 3 : UCIP_FA_2019_11293_18674.jpg

Comment Code					
Inspector Comment					
DS_ID:19374 FS_ID:11293 EP_NO: 9317 Repair Type: No Action Needed Crossing Status: Found UCIP Comments: 01/14/2019 Pipe has been replaved with a 16-inch pipe under permit 9317-1; new DS-ID 25571. (O.Yakimov - DWR UCIP) FIELD_STRUCT_DESC: *REMOVED* 1 of 2: 16-inch steel discharge pipe through the levee, 3 feet below the crown. Pump house on pile structure in drainage ditch on the landside (LS). Siphon breaker on the pipe on the waterside (WS). Service pole at the pump house. (16-inch pipe [HLM 3.97] authorized under Automatic Board Order (ABO) issued as Permit No. 9317, 1974 - Reclamation District No. 819). [Additional Reference(s): DWR Levee Log, 1990. USACE Sacramento O&M Manual 127, June 1953, (Station 211+05) (15-inch pipe listed)]. FS Date: 4/9/2013

Pump and pipes on LS toe.

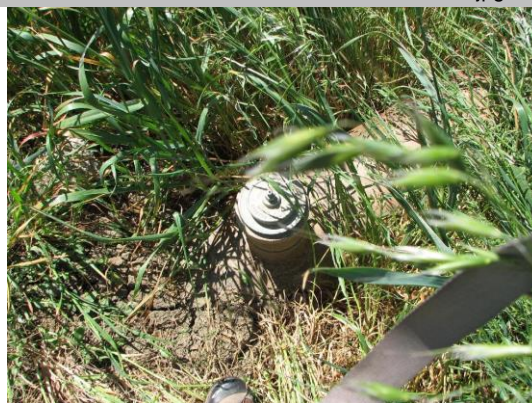
Photo 3 of 3 : UCIP_FA_2019_11293_18673.jpg

Comment Code						
Inspector Comment						
DS_ID:19374 FS_ID:11293 EP_NO: 9317 Repair Type: No Action Needed Crossing Status: Found UCIP Comments: 01/14/2019 Pipe has been replaved with a 16-inch pipe under permit 9317-1; new DS-ID 25571. (O.Yakimov - DWR UCIP) FIELD_STRUCT_DESC: *REMOVED* 1 of 2: 16-inch steel discharge pipe through the levee, 3 feet below the crown. Pump house on pile structure in drainage ditch on the landside (LS). Siphon breaker on the pipe on the waterside (WS). Service pole at the pump house. (16-inch pipe [HLM 3.97] authorized under Automatic Board Order (ABO) issued as Permit No. 9317, 1974 - Reclamation District No. 819). [Additional Reference(s): DWR Levee Log, 1990. USACE Sacramento O&M Manual 127, June 1953, (Station 211+05) (15-inch pipe listed)]. FS Date: 4/9/2013

16-inch pipe with siphon breaker on WS shoulder.

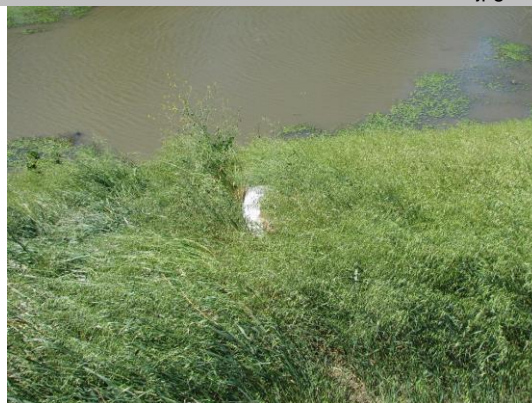
Photo 2 of 3 : UCIP_FA_2019_11291_18668.jpg

Comment Code					
Inspector Comment					
DS_ID:19401 FS_ID:11291 EP_NO: 9317 Repair Type: No Action Needed Crossing Status: Found UCIP Comments: 01/14/2019 Pipe was removed replaced with a new 24-inch pipe through the levee. Permit 9317-1 issues authorization of emergency removal and replacement of the pipe in September 2012. New DS-ID 25572. (O.Yakimov - DWR UCIP) FIELD_STRUCT_DESC: *REMOVED* 2 of 2: 24-inch steel discharge pipe through the levee, 9 feet below the crown. Pump house on pile structure in drainage ditch on the landside (LS). Siphon breaker on the pipe on the waterside (WS) with a butterfly shutoff valve. Service pole at the pump house. (Permit No. 9317, 1974 - Reclamation District No. 819). Pipe replaced in 2012. [Additional Reference(s): DWR Levee Log, 1990. USACE Sacramento O&M Manual 127, June 1953, (Station 210+99)]. FS Date: 4/9/2013

Pipe in grass on WS shoulder.

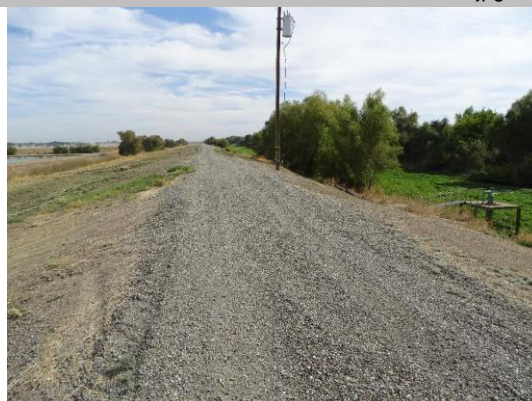
Photo 1 of 3 : UCIP_FA_2019_55777_82798.jpg

Comment Code						
Inspector Comment						
DS_ID:19375 FS_ID:55777 EP_NO: 3671 Repair Type: Non-Urgent Crossing Status: Found UCIP Comments: 10/08/2019 Crossing looks abandoned (O.Yakimov - DWR UCIP)04/09/2013 Electrical panel missing parts. Siphon breaker missing from pipe on LS. Pipe heavily corroded at outlet with holes present. Appears abandoned-should be abandoned properly. FIELD_STRUCT_DESC: 20-inch coated steel irrigation pipe through the levee, 5.5 feet below the crown. Siphon breaker in a steel pipe riser on the landside (LS) slope. Metal cutoff wall. Service pole on the waterside (WS) slope. (Replaced 20-inch pipe at same location in 1961 under Permit No. 3671, 1961 - Mary Anna Richardson). [Additional Reference(s): DWR Levee Log, 1990]. FS Date: 10/8/2019

View of levee crown at the crossing

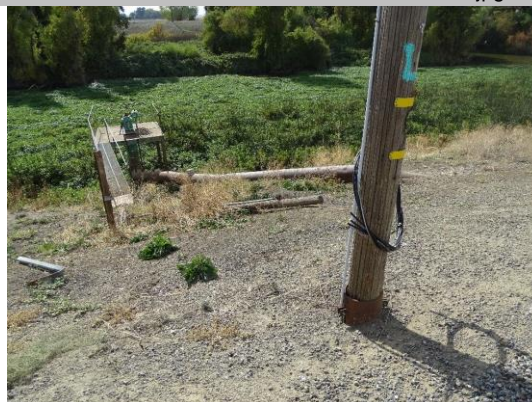
Photo 2 of 3 : UCIP_FA_2019_55777_82799.jpg

View of WS looking from levee crown

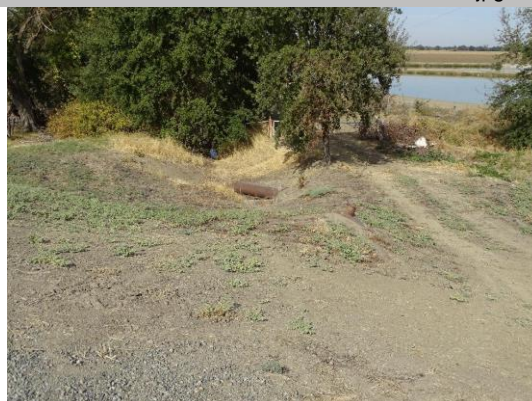
Photo 3 of 3 : UCIP_FA_2019_55777_82801.jpg

Comment Code						
Inspector Comment						
DS_ID:19375 FS_ID:55777 EP_NO: 3671 Repair Type: Non-Urgent Crossing Status: Found UCIP Comments: 10/08/2019 Crossing looks abandoned (O.Yakimov - DWR UCIP)04/09/2013 Electrical panel missing parts. Siphon breaker missing from pipe on LS. Pipe heavily corroded at outlet with holes present. Appears abandoned-should be abandoned properly. FIELD_STRUCT_DESC: 20-inch coated steel irrigation pipe through the levee, 5.5 feet below the crown. Siphon breaker in a steel pipe riser on the landside (LS) slope. Metal cutoff wall. Service pole on the waterside (WS) slope. (Replaced 20-inch pipe at same location in 1961 under Permit No. 3671, 1961 - Mary Anna Richardson). [Additional Reference(s): DWR Levee Log, 1990]. FS Date: 10/8/2019

View of WS looking from levee crown

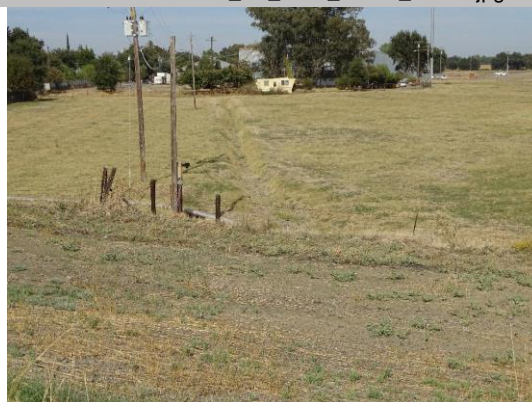
Photo 1 of 3 : UCIP_FA_2019_55779_82815.jpg

Comment Code					
Inspector Comment					
DS_ID:19376 FS_ID:55779 EP_NO: 12738 Repair Type: Non-Urgent Crossing Status: Found UCIP Comments: 10/08/2019 Crossing looks abandoned (O.Yakimov - DWR UCIP) FIELD_STRUCT_DESC: 10-inch coated steel irrigation pipe through the levee, 4 feet below the crown. Pump on the waterside (WS) bank, and siphon breaker on the WS slope. Electrical service line parallel to pipe. Electrical service line and pole at the landside (LS) toe. (Permit No. 12738-D, 1999 - Donald R. Newman [permit not found in database]). Design drawings available in permit. [Additional Reference(s): DWR Levee Log, 1990]. FS Date: 10/8/2019 3:57:22 PM

View of LS looking from levee crown

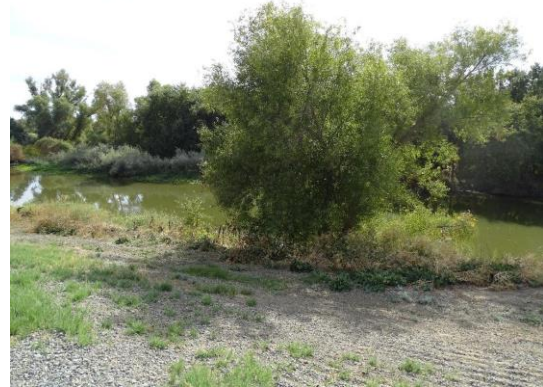
Photo 2 of 3 : UCIP_FA_2019_55779_82816.jpg

Comment Code						
Inspector Comment						
DS_ID:19376 FS_ID:55779 EP_NO: 12738 Repair Type: Non-Urgent Crossing Status: Found UCIP Comments: 10/08/2019 Crossing looks abandoned (O.Yakimov - DWR UCIP) FIELD_STRUCT_DESC: 10-inch coated steel irrigation pipe through the levee, 4 feet below the crown. Pump on the waterside (WS) bank, and siphon breaker on the WS slope. Electrical service line parallel to pipe. Electrical service line and pole at the landside (LS) toe. (Permit No. 12738-D, 1999 - Donald R. Newman [permit not found in database]). Design drawings available in permit. [Additional Reference(s): DWR Levee Log, 1990]. FS Date: 10/8/2019 3:57:22 PM

View of WS looking from levee crown

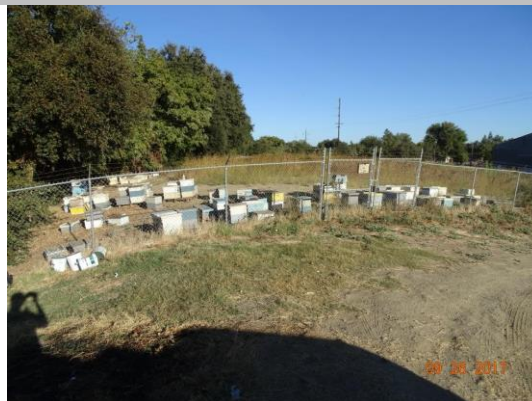
Photo 1 of 2 : FA_2019_NA0008_257_1_20190829_00001.jpg

LM Start	5.94	Rating **	U	Issue No.	1
LM End	5.94	Issue Type +	En	Location *	CR
Category	Earthen Levee			GPS Latitude/Longitude	
				Start	End
Item	Encroachments			38.792735 °	38.792735 °
				-121.724092 °	-121.724092 °
DWR ID	DWR_NA0008_02_s_2012_1				
Comment Code					
FE : Fence					
Inspector Comment					
A fence blocks access to NW part of the levee. Strawberries are being grown on the crown and landside slope. Beehives are on the crown.

View of the fence on the crown. Fall 2017.

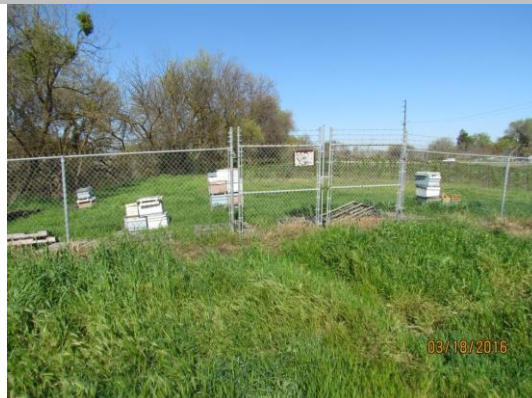
Photo 2 of 2 : FA_2019_NA0008_257_1_20190829_00002.jpg

LM Start	5.94	Rating **	U	Issue No.	1 (cont)	
LM End	5.94	Issue Type +	En	Location *	CR	
Category	Earthen Levee			GPS Latitude/Longitude		
				Start		End
Item	Encroachments			38.792735 °		38.792735 °
				-121.724092 °		-121.724092 °
DWR ID	DWR_NA0008_02_s_2012_1					
Comment Code						
FE : Fence						
Inspector Comment						
A fence blocks access to NW part of the levee. Strawberries are being grown on the crown and landside slope. Beehives are on the crown.

View of the fence on the crown of the levee looking upstream. Spring 2016.
